**Australian Government**  
**Department of Defence**  
Defence Science and  
Technology Organisation

# Corrosion of Hawk Lead-in-Fighter Hydraulic Pipe Work

DSTO-TR-1833

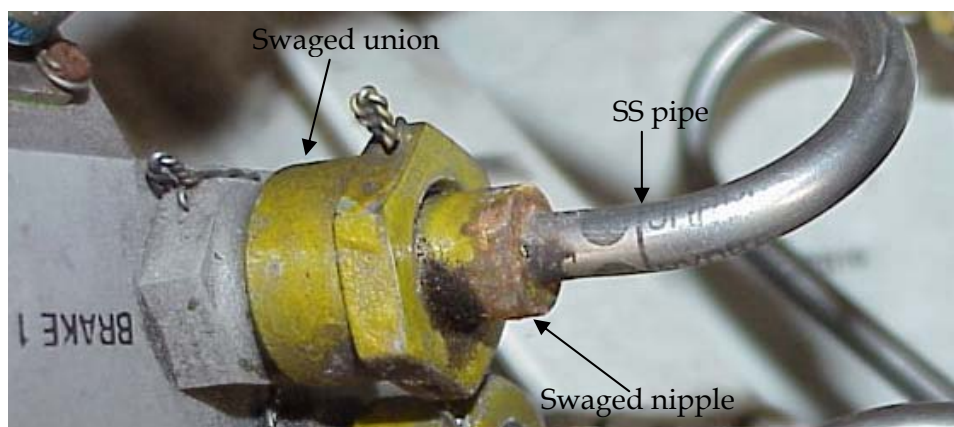
The pipe work which carries hydraulic fluid and nitrogen consisted of piping manufactured from BS T72 stainless steel and swaged unions and nipples manufactured from BS S154 alloy steel. It was not known if the stainless steel had been passivated. The swaged unions and nipples were protected with a cadmium coating that was chromate conversion coated (CCC) and a polyurethane lacquer. Figure 1 shows a pipe fitting with white, grey and brown/red corrosion product, indicative of both cadmium and steel corrosion.

Figure 1: Corroded pipe fitting

1. If a suitable coating is applied to the first few centimetres of stainless steel pipes adjacent to the swaged connections, the risk of galvanic corrosion will be reduced. An alternative is to use a corrosion prevention compound conforming to Boeing Material Specification BMS 3-35, for example: Dinitrol AV15 or Cor-Ban 35.
2. If the stainless steel pipes are given a suitable passivation treatment, then any failure of the coating applied in step 1 should not result in significant corrosion of the cadmium.
3. Ensuring that the unions and nipples have the correct cadmium coating thickness will extend the life of the fittings.

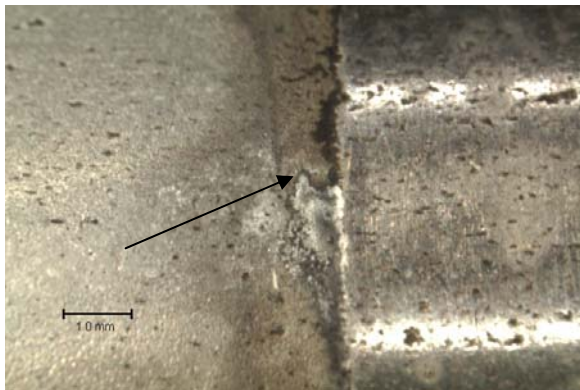
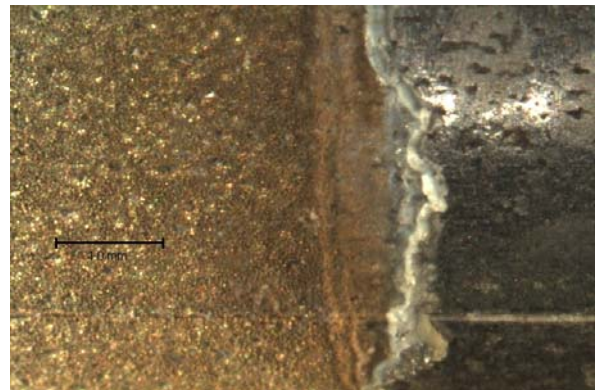
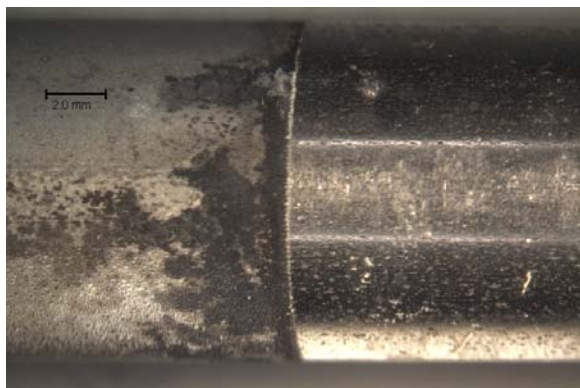
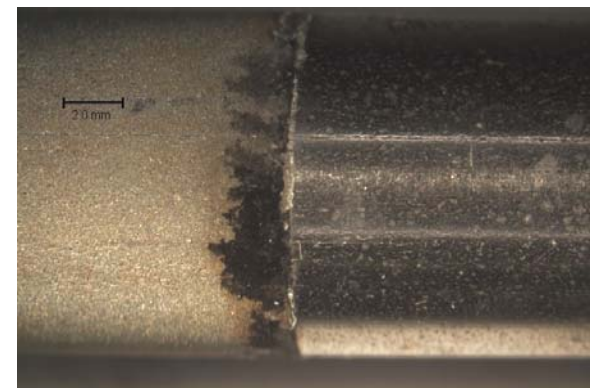
Figure 23: Corrosion of cadmium coated stainless steel after 10 days in 85% RH air

Figure 24: Corrosion of CCC cadmium coated stainless steel after 10 days in 85% RH air

Figure 25: Corrosion of cadmium coated stainless steel after 46 days in 85% RH air

Figure 26: Corrosion of CCC cadmium coated stainless steel after 46 days in 85% RH air

The distance that corrosion extended from the cadmium/stainless steel interface was approximately 3-4 mm. This is in agreement with the theoretical calculation of 3.5 mm over which the galvanic interaction between cadmium and stainless steel may extend when covered by a thin moisture film (Appendix A).

galvanic interaction occurred over a short distance of approximately 3-4 mm from the galvanic interface. It therefore follows that if the stainless steel was painted for at least this distance, the corrosion may not occur. This has subsequently been confirmed by correspondence with BAE SYSTEMS which stated that corrosion of the hydraulic parts was not a problem in the RAF fleet [4]. An image of an in-service part supplied by BAE SYSTEMS clearly indicated a protective coating present over the first few centimetres from the swaged galvanic interface. A protective coating applied in this manner will prevent galvanic interaction between the cadmium and the stainless steel in atmospheric conditions.

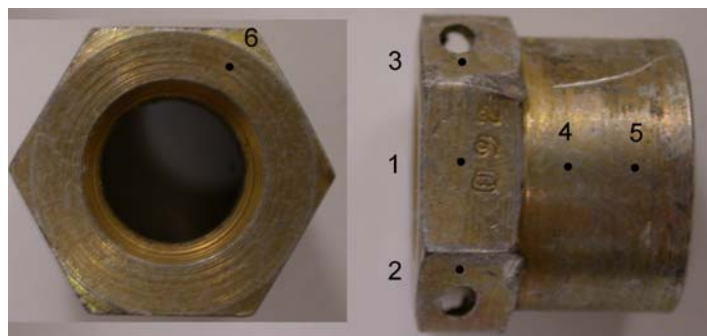
Figure 27: Cadmium thickness measurement locations on swaged union

Location	Average Thickness from 3 measurements, $\mu\text{m}$		
	As new component	Least corroded end from Hawk A27-17	Most corroded end from Hawk A27-17
1	13.1	5.2	2.9
2	13.5	5.1	2.7
3	9.0	5.1	3.3
4	10.0	4.0	2.7
5	10.0	4.4	3.5
6	Not accessible	4.2	2.4

The cadmium plating thicknesses on the unions and nipples were less than the minimum requirements of DEF(STAN) 03-19/2, Amendment 1 (21/11/96). The cadmium plating thickness measurements taken on the swaged unions of as new pipe work, supplied by TFSPO, were greater than the minimum requirements of DEF(STAN) 03-19/2, Amendment 1 (21/11/96). The thickness measurements taken from the swaged nipples on the new pipe work were generally greater than the minimum requirements, with the exceptions of locations 2 and 7.

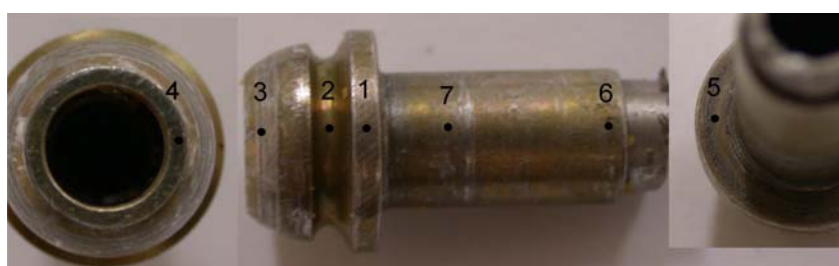
Figure 28: Cadmium thickness measurement locations on swaged nipple

Location	Average Thickness from 3 measurements, $\mu\text{m}$		
	As new component	Least corroded end from Hawk A27-17	Most corroded end from Hawk A27-17
1	10.0	3.3	3.3
2	7.4	3.2	3.2
3	11.0	3.4	3.1
4	Not accessible	2.9	2.5
5	Not accessible	2.7	2.0
6	13.0	4.9	Corroded
7	8.0	3.9	Corroded
